Eliminate Dust, debris, hairing chunks or feathering.

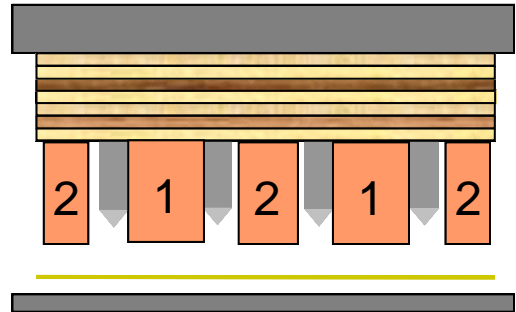
Unbalanced rubbering can also cause premature wear on the rule. Lateral pressure being pushed against the side of the rule allowing it to rub against the cutting plate. This movement is extremely slight but no matter how small, over time and multiple strikes, the rule wears. Tight slot areas are most susceptible due to too much rubber in the slot.

Rubber #1 fills the slot completely so when it is compressed it can only put force on the side of the rule. Rubber #2 has clearance from the rule allowing the pressure from the #1 rubber to force the rule into the gap.

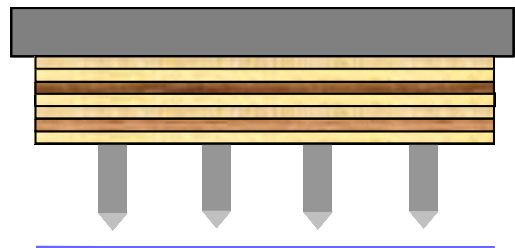
Damaged Plates

An uneven cutting plate on top of a backing plate will also cause premature wear on the steel rule. The uneven plate will also develop gouges which allow the rule and diecut product to "sink in" causing even more debris to accumulate.

Once the cut plate is damaged the material will not cut cleanly, the material will be pushed into the plate. The material then embosses, rips and tears at the point of pressure further compounding the debris problem.

Once the plate is damaged the make ready becomes more difficult and you end up chasing your tail trying to get the parts to cut cleanly.

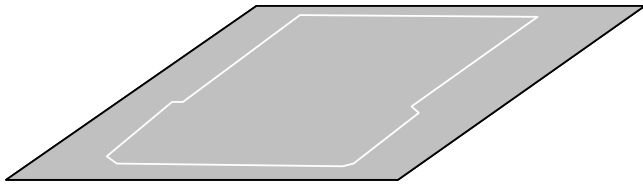
This picture shows a plate with the last die cut part impressed into it.

The indentation of the plate causing more debris problems.

Once the plate has been indented by the steel rule combined with the flattened cut edge of the rule and the multiple plate indentations, the debris problem gradually gets worse.

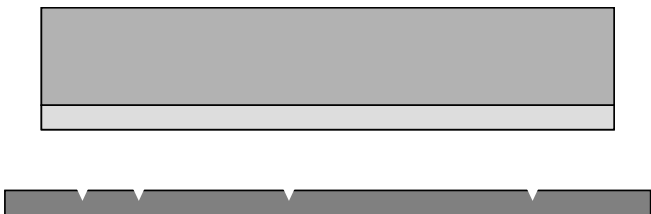
The parts do not cut completely through the material leaving nicks or uncut material on the parts.

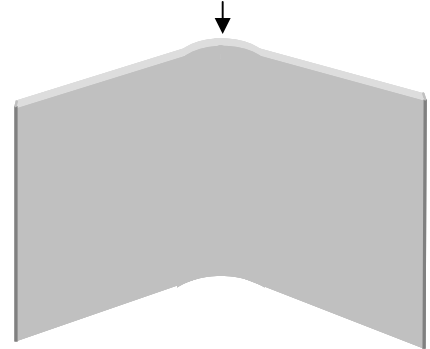
Bends in rule

When rule is bent some distortion occurs and the height of the rule at the corner changes. Usually the rule is slightly higher at the bend point. This causes a number of problems, the rule at the bend point damages the cutting plate and the rule also becomes dull. This causes uneven cutting, prompting more patch up work.

This picture shows an exaggeration of the height change at the point of the bend. But you can see the problems a change like this would make on Press. This is an even bigger problem when the part is to be kiss cut.
